Environmental surveys, management and land degradation in the Murrumbidgee river catchment

A project funded by Friends of the Five Forests

July 2023

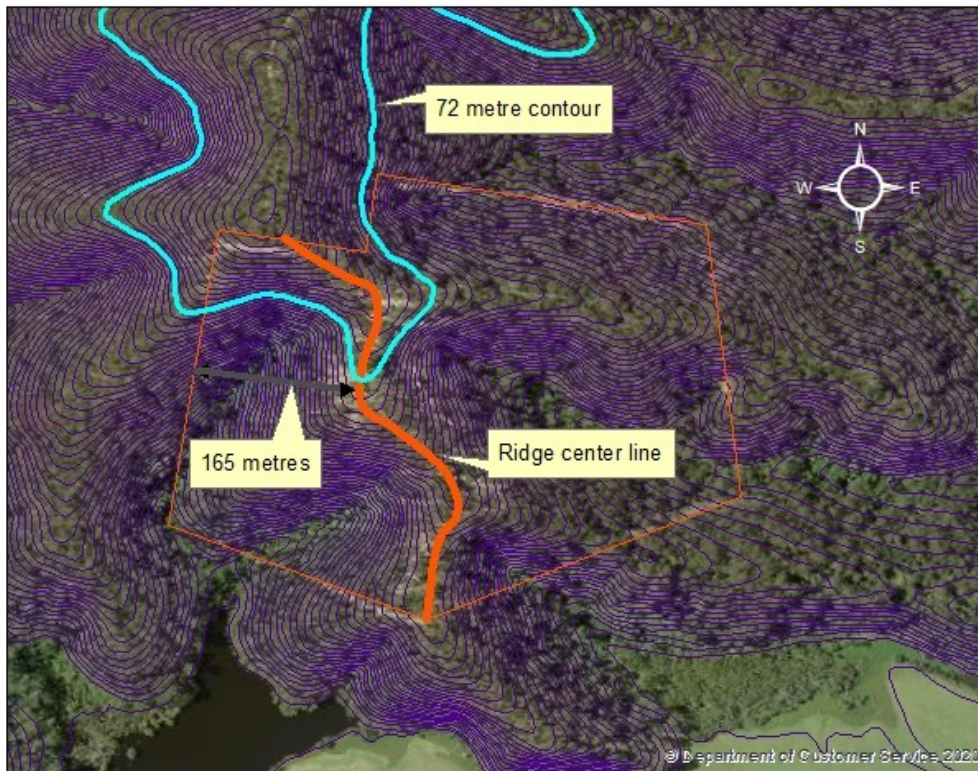
The NSW Police guide suggests permissive shooting rights may apply, among other things in the advent that ‘Projectiles may encroach on land owned by you’. The map below² shows the center of the ridge (red line) where most of the clearing is apparent and the 72 metre contour line (blue line). The distance between the intersection of these lines and the western boundary of the property is 165 metres. All of the land below the junction of the ridge line and the 72 metre contour is down-slope. If shooting is directed to the west, it most likely the lead fallout area includes the Murrah Flora reserve.

Contour lines on the image above are derived from Light Detection and Ranging technology (LIDAR), suggesting zero order water-courses are also present on the property.

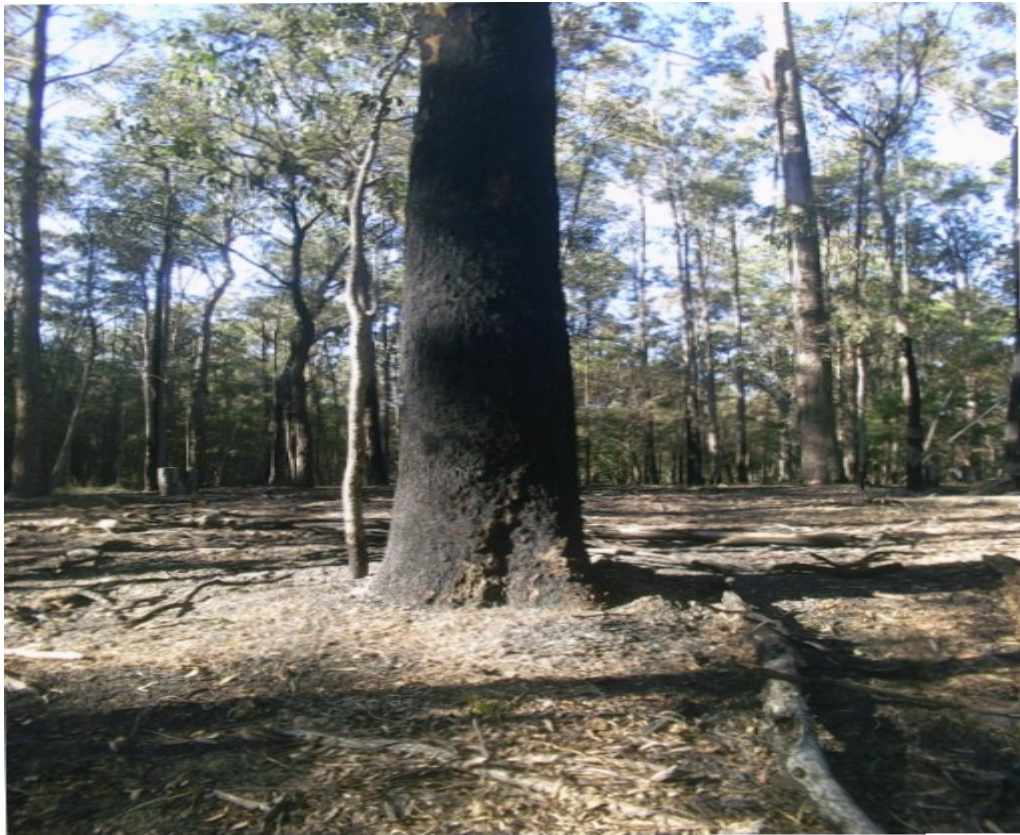
The following photo shows the outcome from one of the cultural burns, undertaken in Mumbulla state forest during 2022. The tree was scorched for several metres up its trunk, some surrounding trees were killed in the burn and others have died since that time.

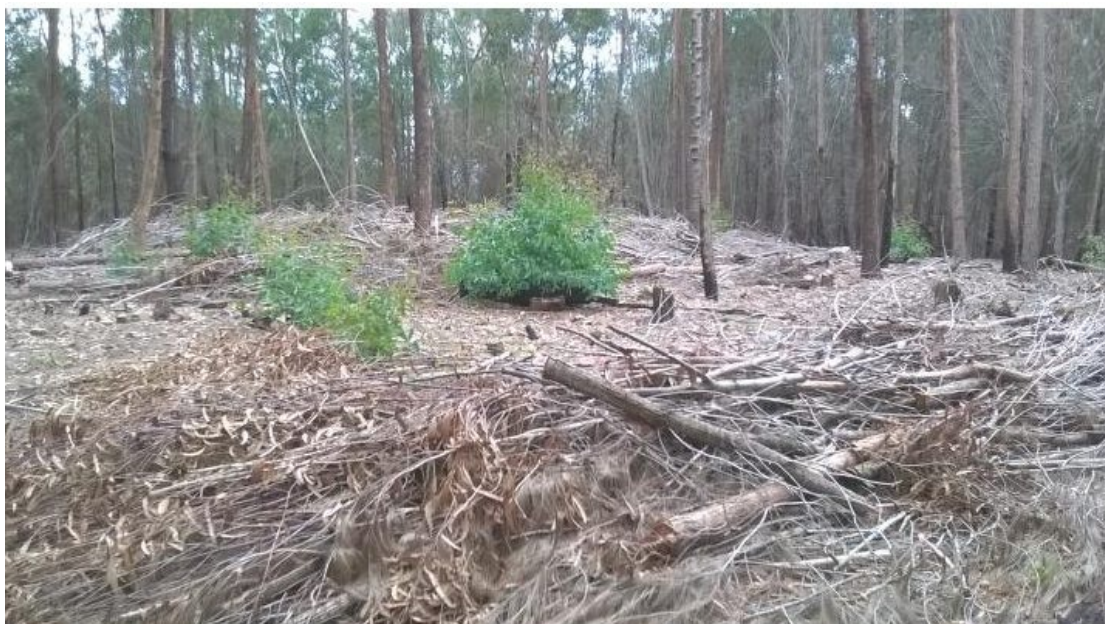
The photo above shows one of the plots some months after thinning in Murrah state forest. Black forest oak generally does not coppice after being cut down, although silver-top ash and other eucalypts do. While it is apparent this probable outcome was not considered, the significant loss and degradation of soils from logging and burning was also not considered.

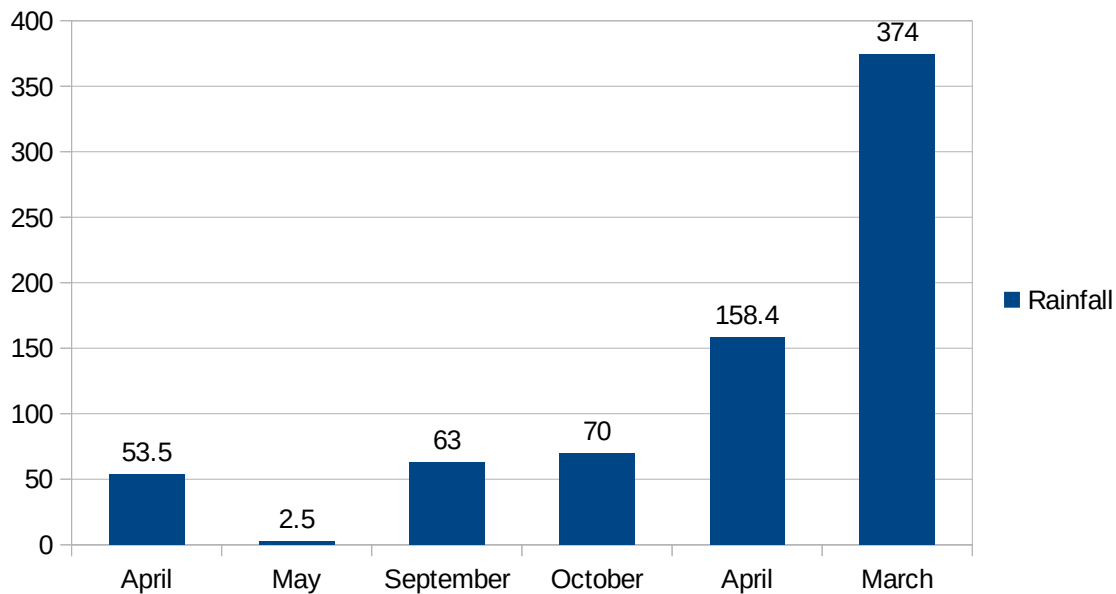
The following chart provides rainfall in millimetres, recorded at the Murrah for the two months prior to the ERM study (April and May 2021), the sampling reported here (September and October 2021) and subsequent observations of turbidity at three sites (April and March 2022).

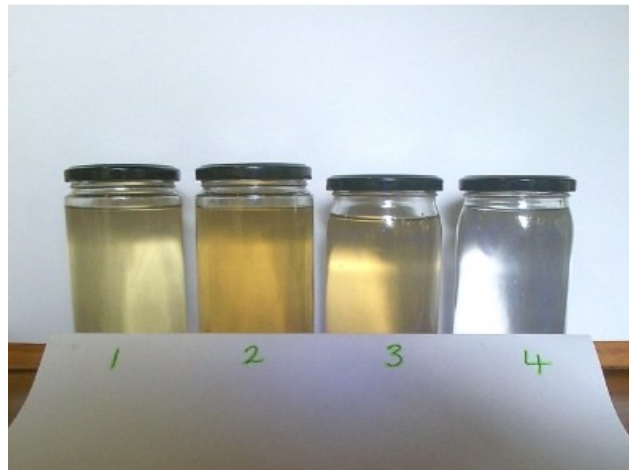
The following photo shows water clarity samples taken during elevated flows on April 8 2022. Number 1 is from Mumbulla creek (2,103 ha.) number 2 at Knights creek (812 ha.), up stream of the site KC1 due to accessibility constraints and number 3 from the unnamed creek (181 ha.) at site PC1. Number 4 is rainwater.

A secchi disc was employed at sites KC1 and PC1 during sampling when water at the latter site appeared more turbid, but the disc was still visible at 80cm deep. On the second visit during higher flows KC1 wasn't accessible. At site PC1 the disc had vanished from view at a depth of 60cm.

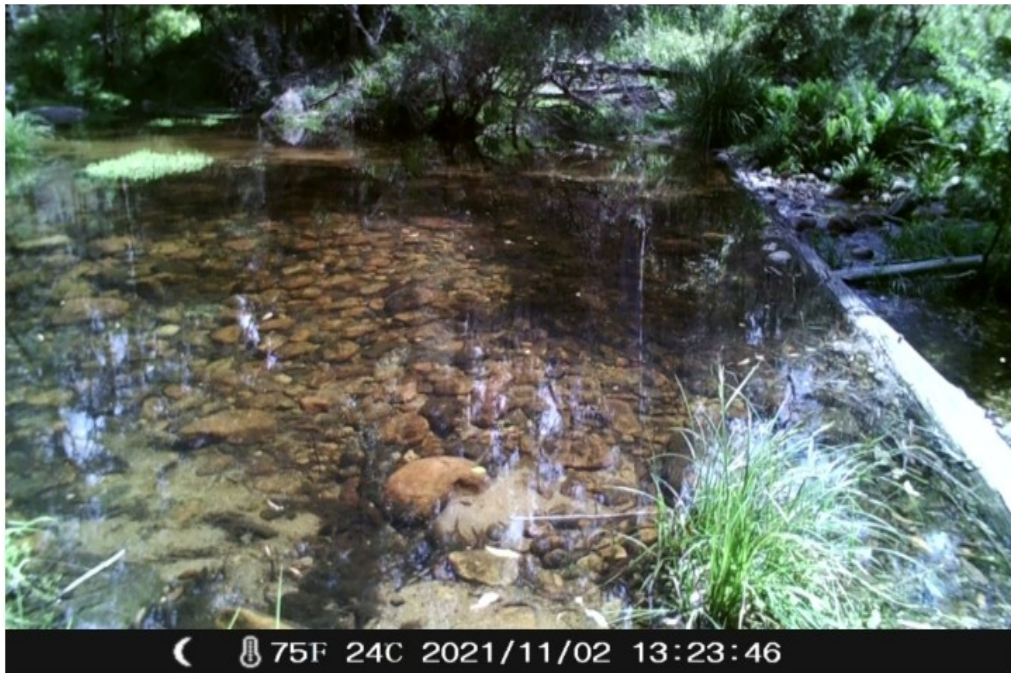
Mumbulla creek site – MC1 with moderate flow

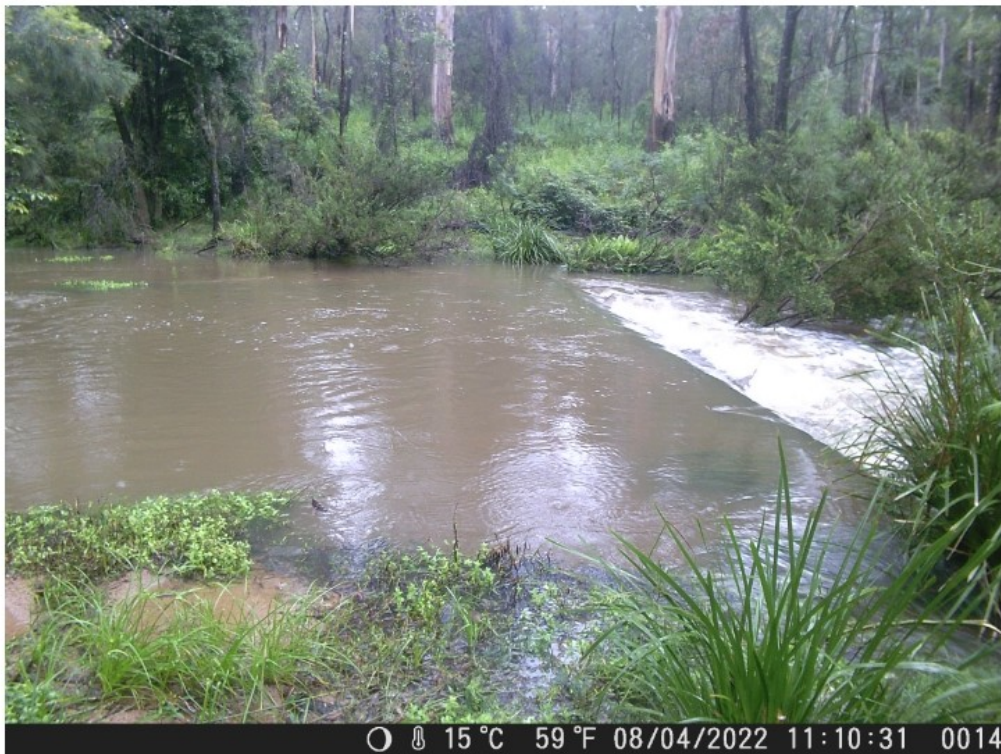
Mumbulla creek site – MC1 with higher flow

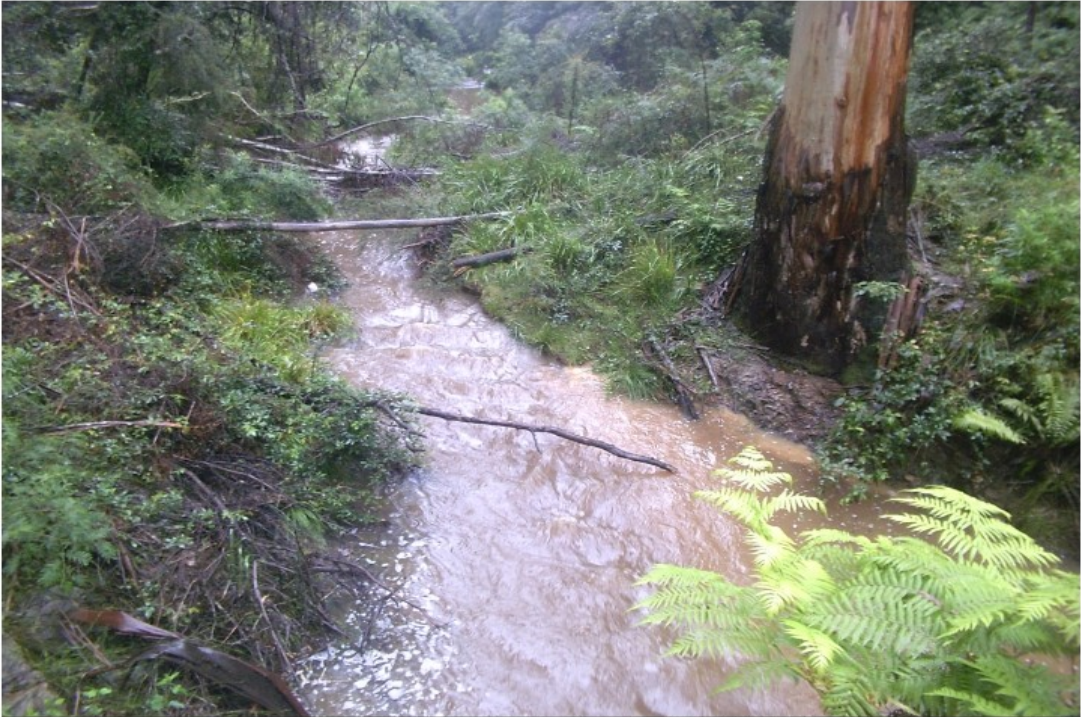
Knights creek – site KC2 during higher flow

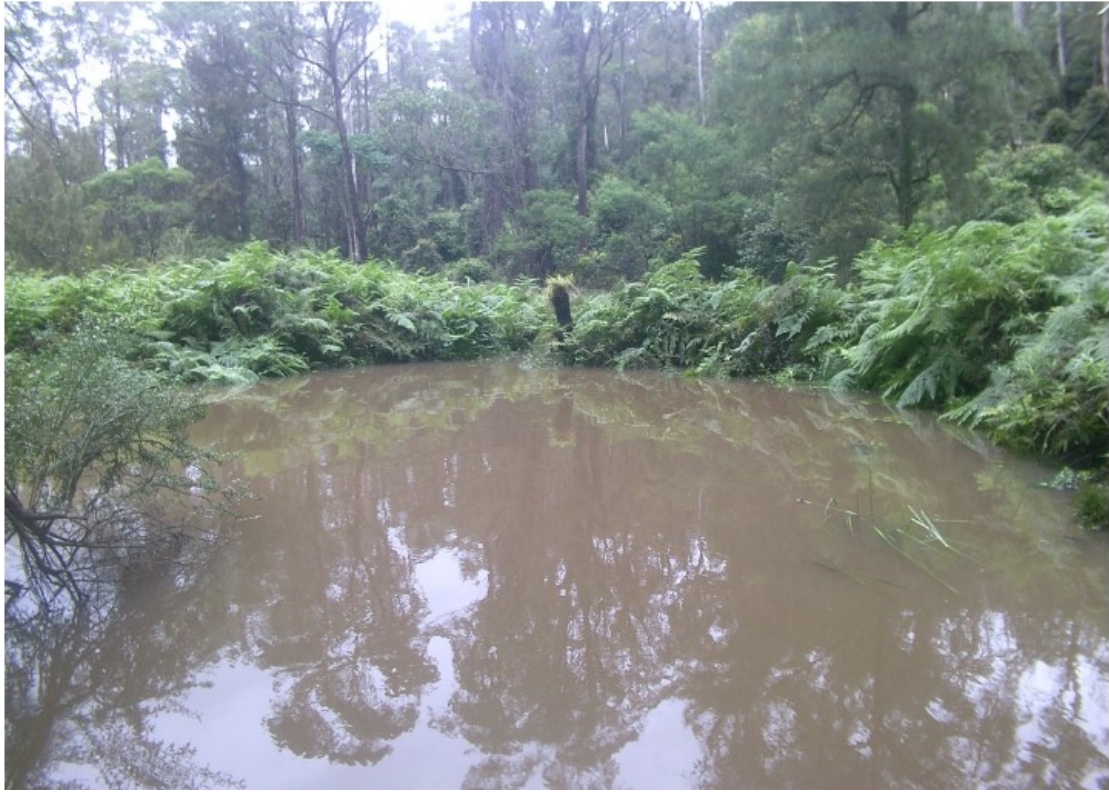
Unnamed catchment – site PC1 during higher flow

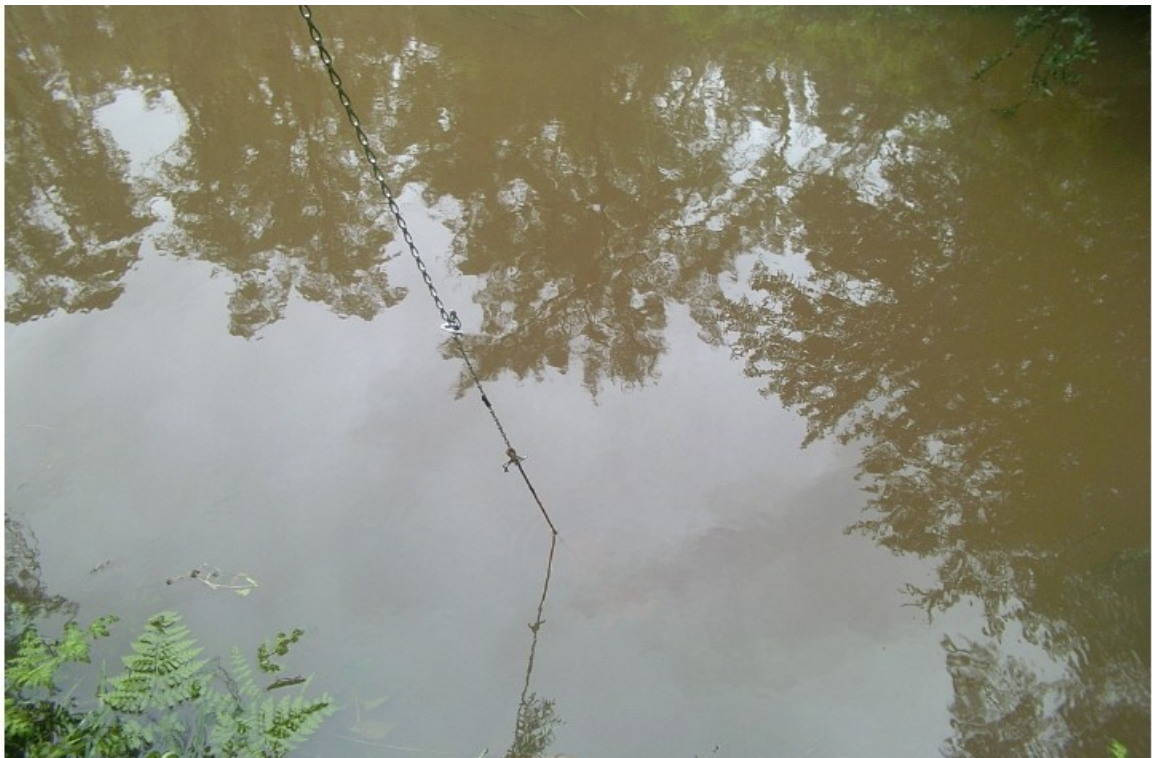
Unnamed catchment – site PC1 with Secchi disc disappearing

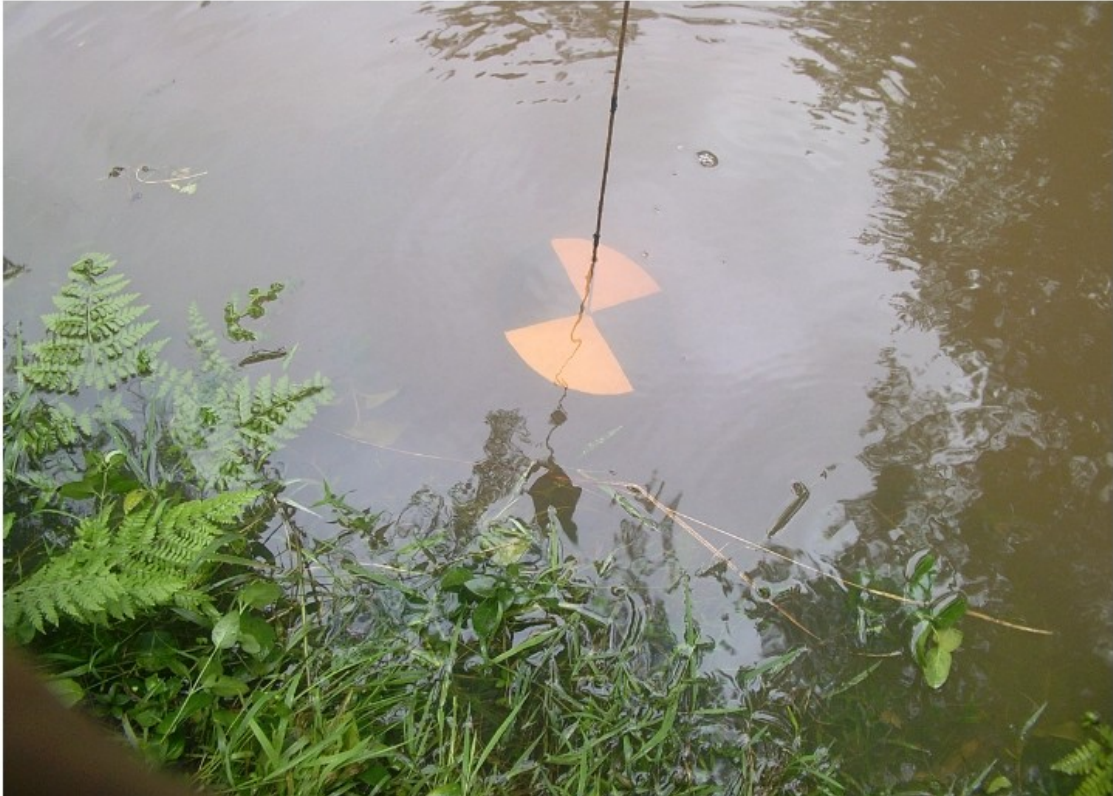
Unnamed catchment – site PC1 with Secchi disc reappearing

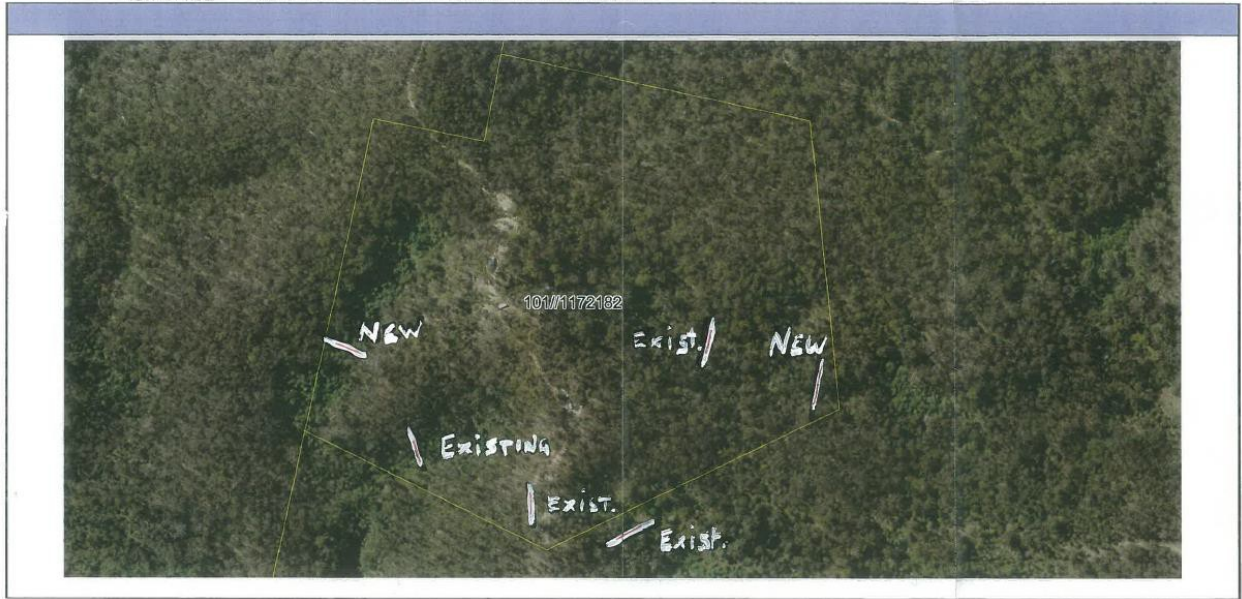
13 JUNE 2013

NEW & EXISTING SILT BARRIERS AT BERMAGUI FIELD & GAME PROPERTY — MURRAH RIVER ROAD
NEW — INSTALLED 2013, AFTER LAND PURCHASE
EXISTING — INSTALLED 1998 PRIOR TO LAND PURCHASE
